**US Army Corps
of Engineers®**
Portland District

Oregon International Port of Coos Bay

Proposed Section 204(f)/408 Channel Modification Project

Geophysical Assessment and Reports

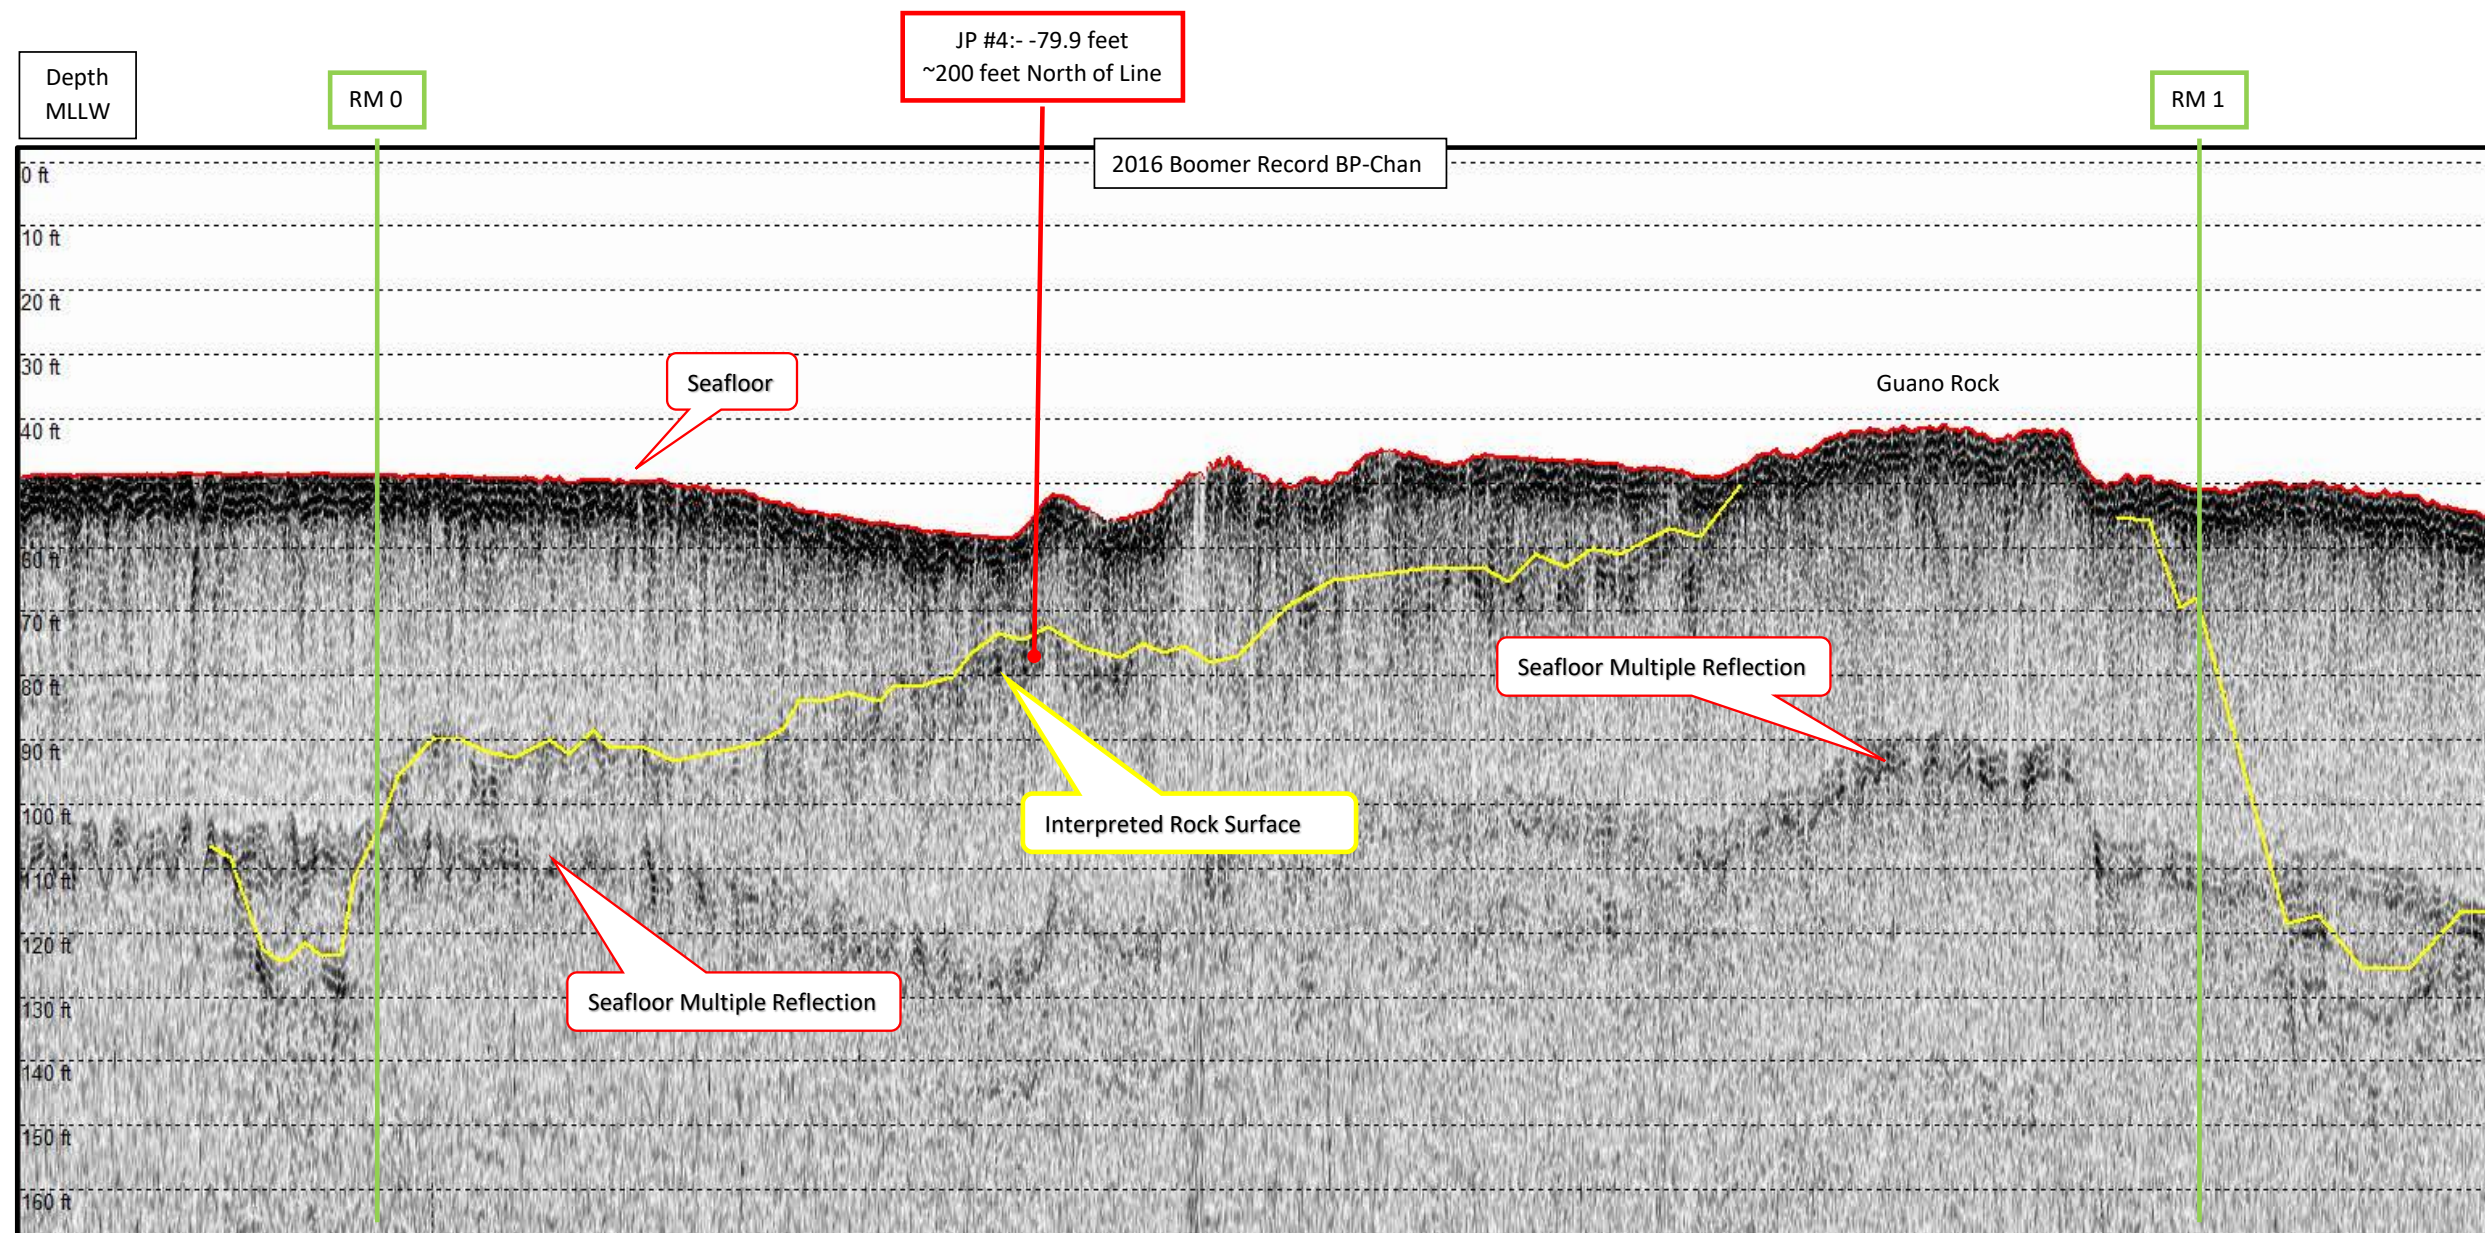
Figure 7: Seismic profile (boomer) BP-Chan, looking north along center line of entrance channel between RM 0 and RM 1

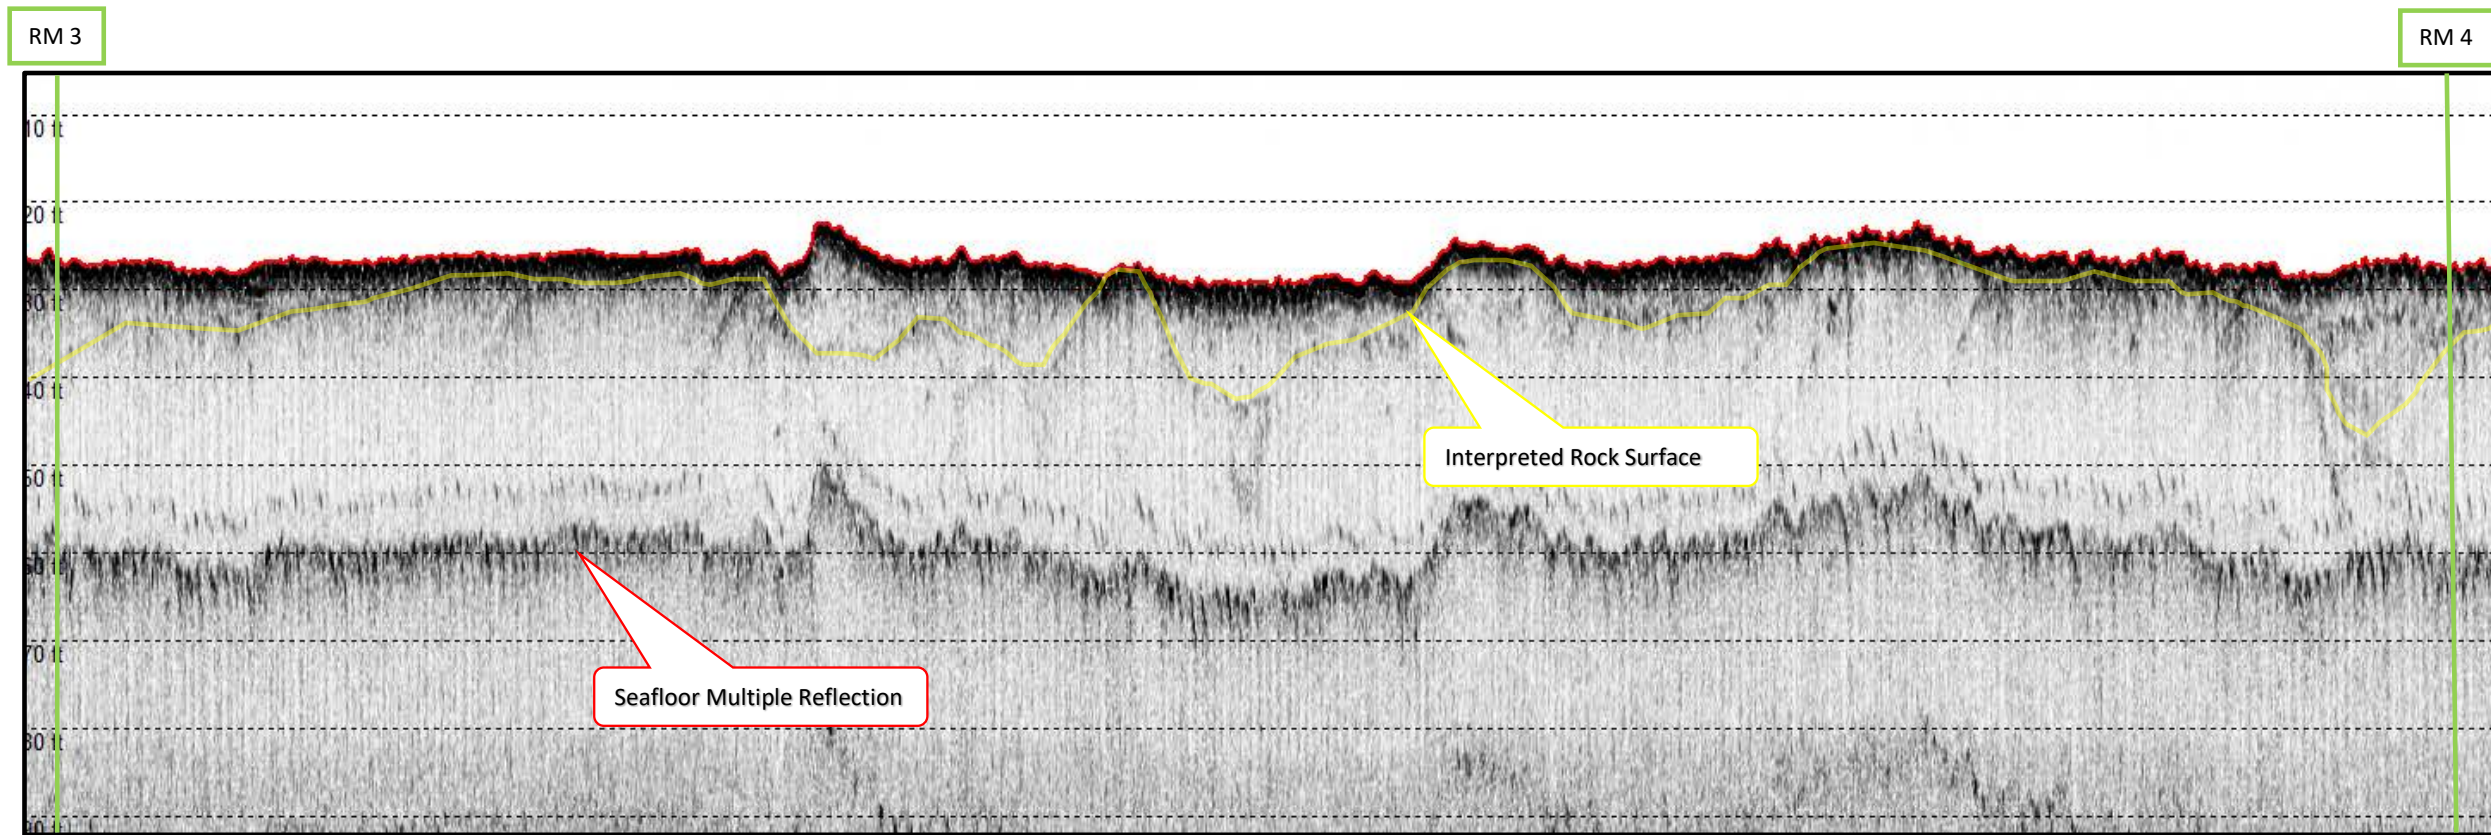
Figure 15: 2008 CHIRP line CB_RNG_250W (250 feet west of channel edge) between RM 3 and RM 4, showing undulating rock surface (yellow highlight) (High spots probably reflect more resistant units and correlate to the exposed rock pattern previously discussed in Figure 14. Elevations are relative to MLLW.)

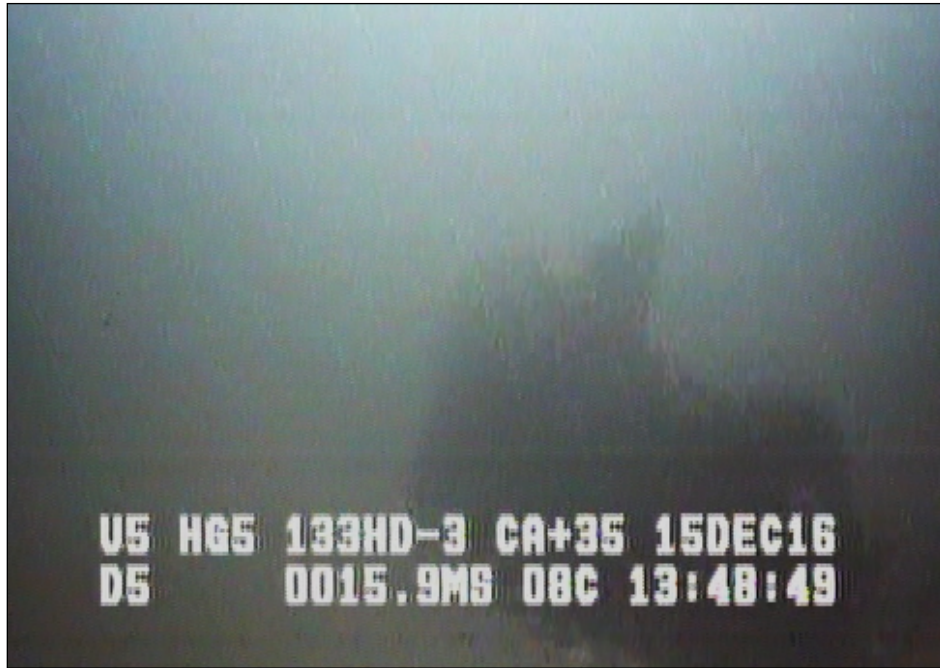
Figure 14: Debris on seafloor outboard of *Rossell* on starboard side.

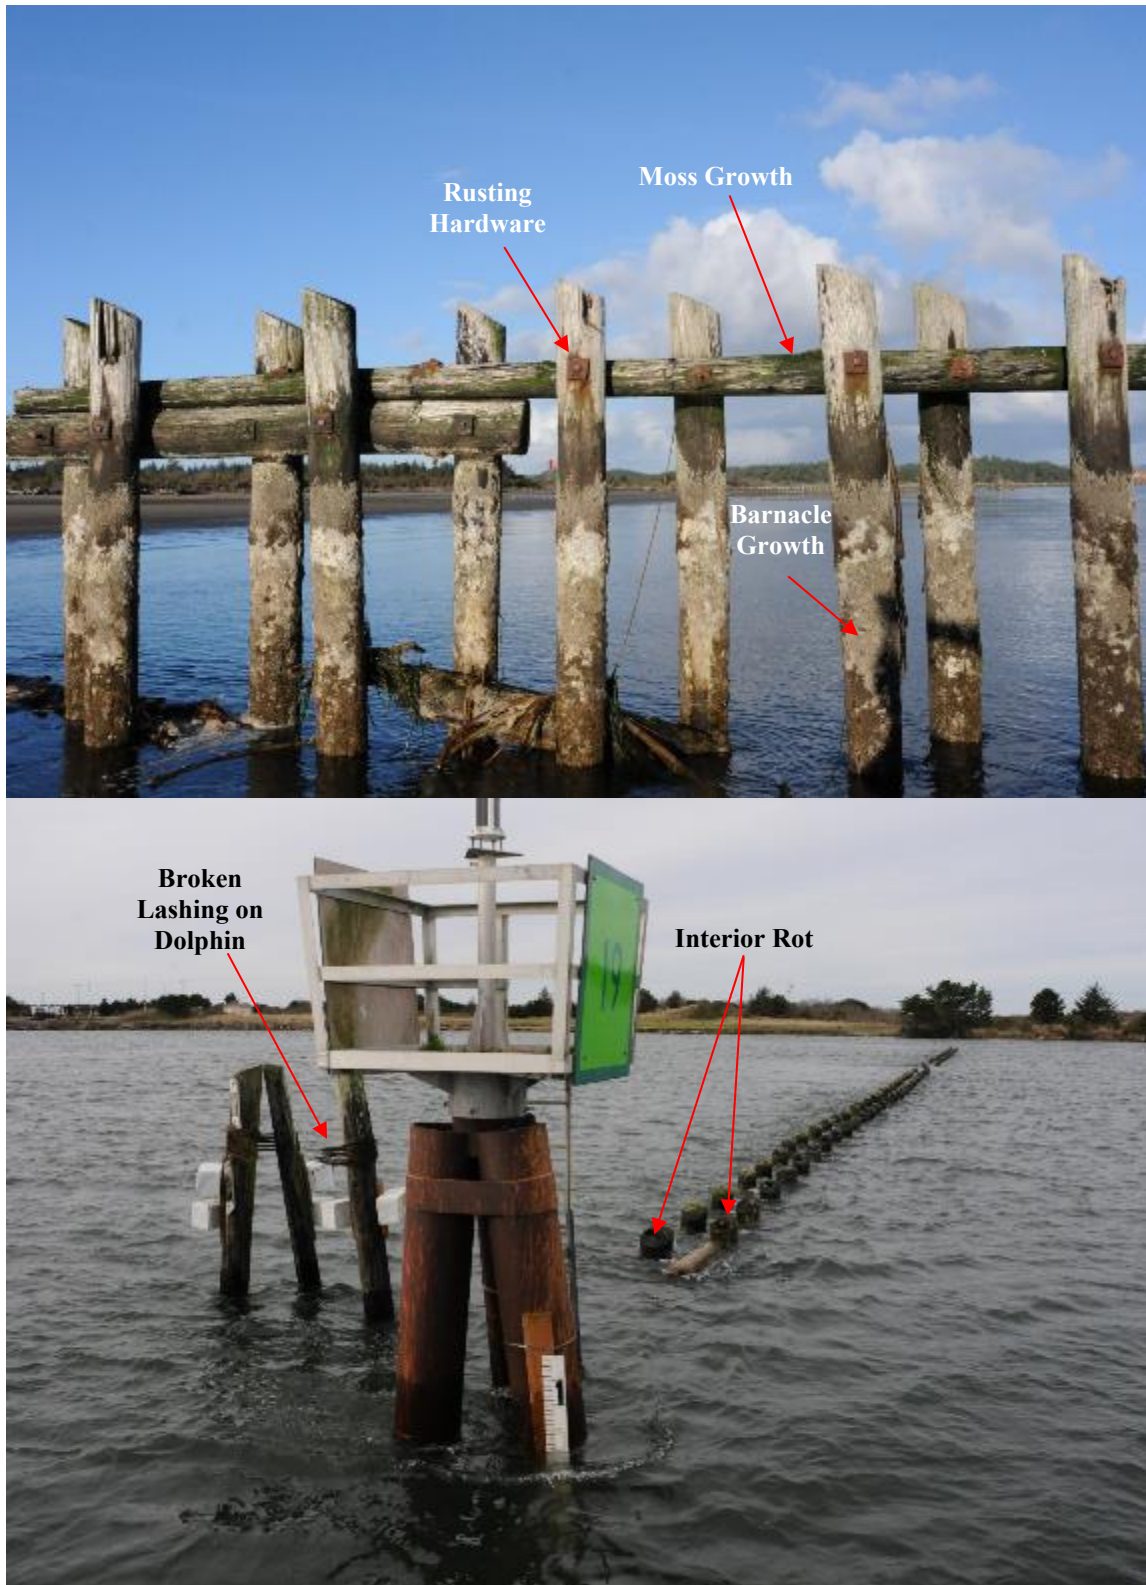
Figure 23. Pile Dike 6.8 photographs depicting the condition of the piles and hardware.

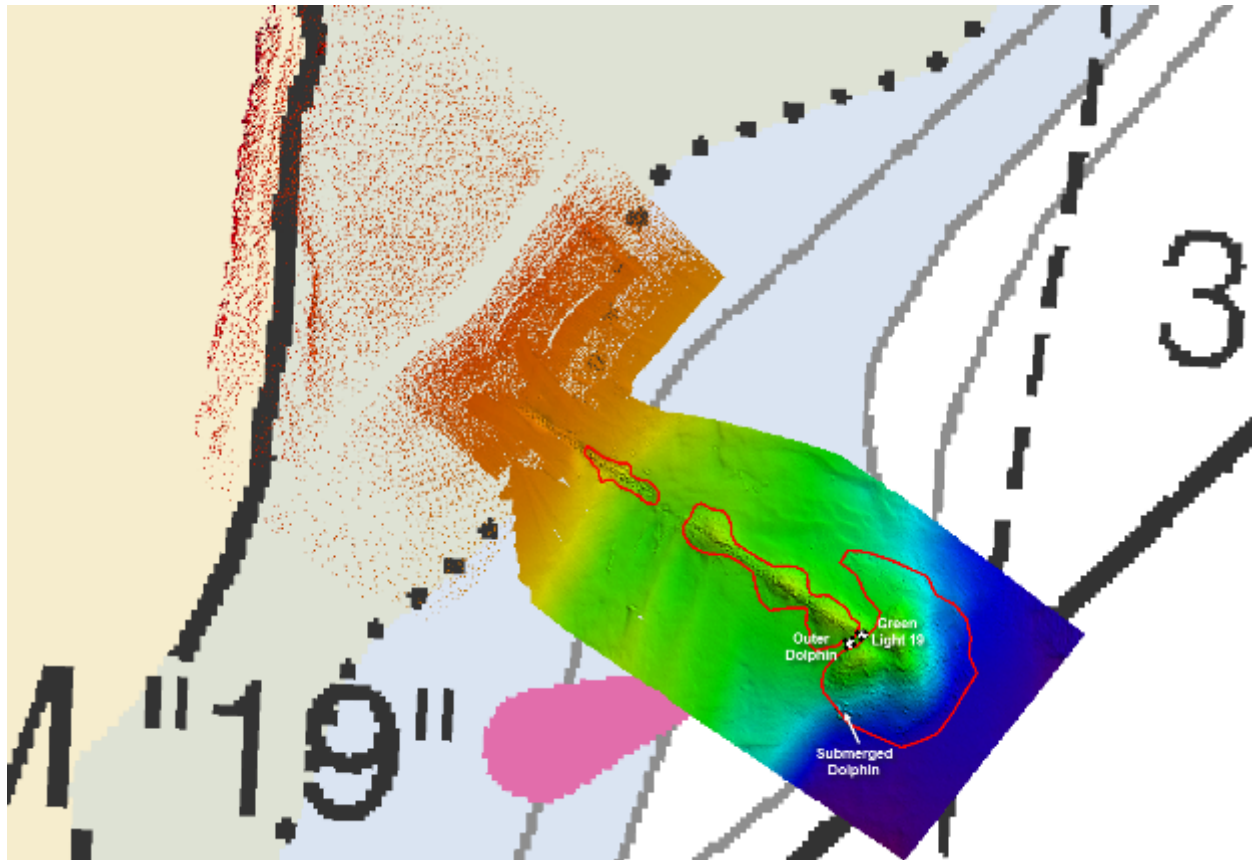
Figure 24. Pile Dike 6.8 plan view bathymetric hillshade depicting the extent of exposed armor rock (outlined in red) and the location of the baring outer dolphin, green light 19 and submerged dolphin.

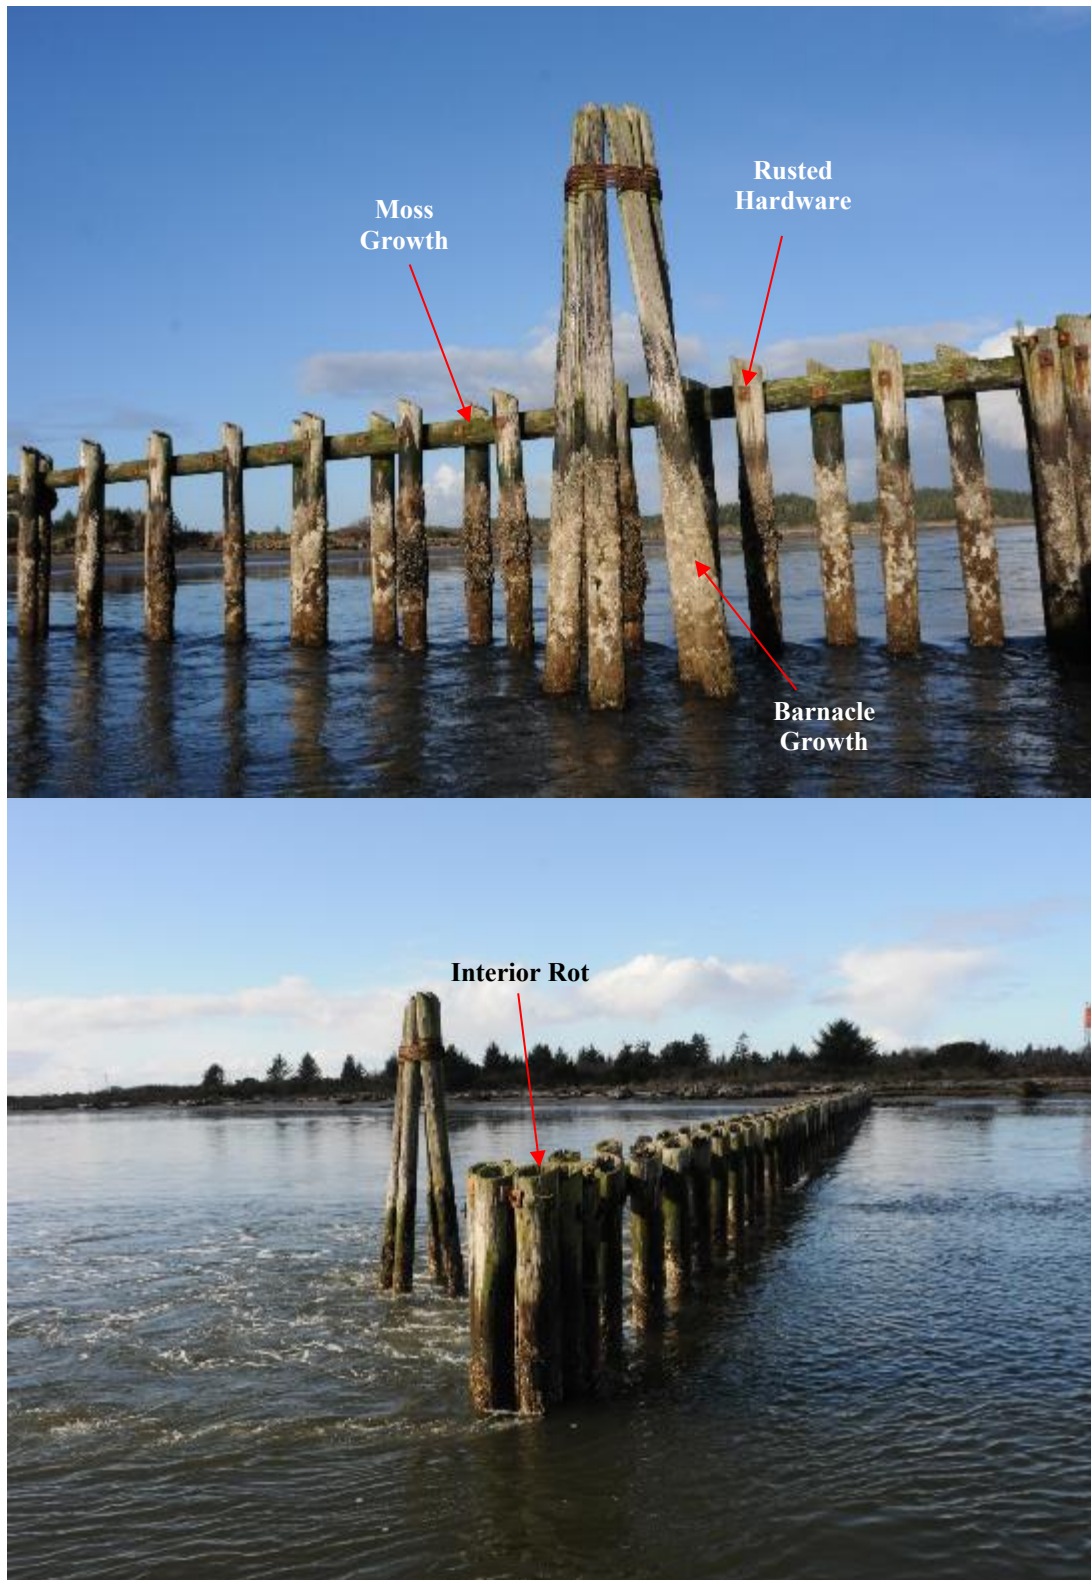
Figure 30. Pile Dike 7.0 photographs of the pile condition and hardware.

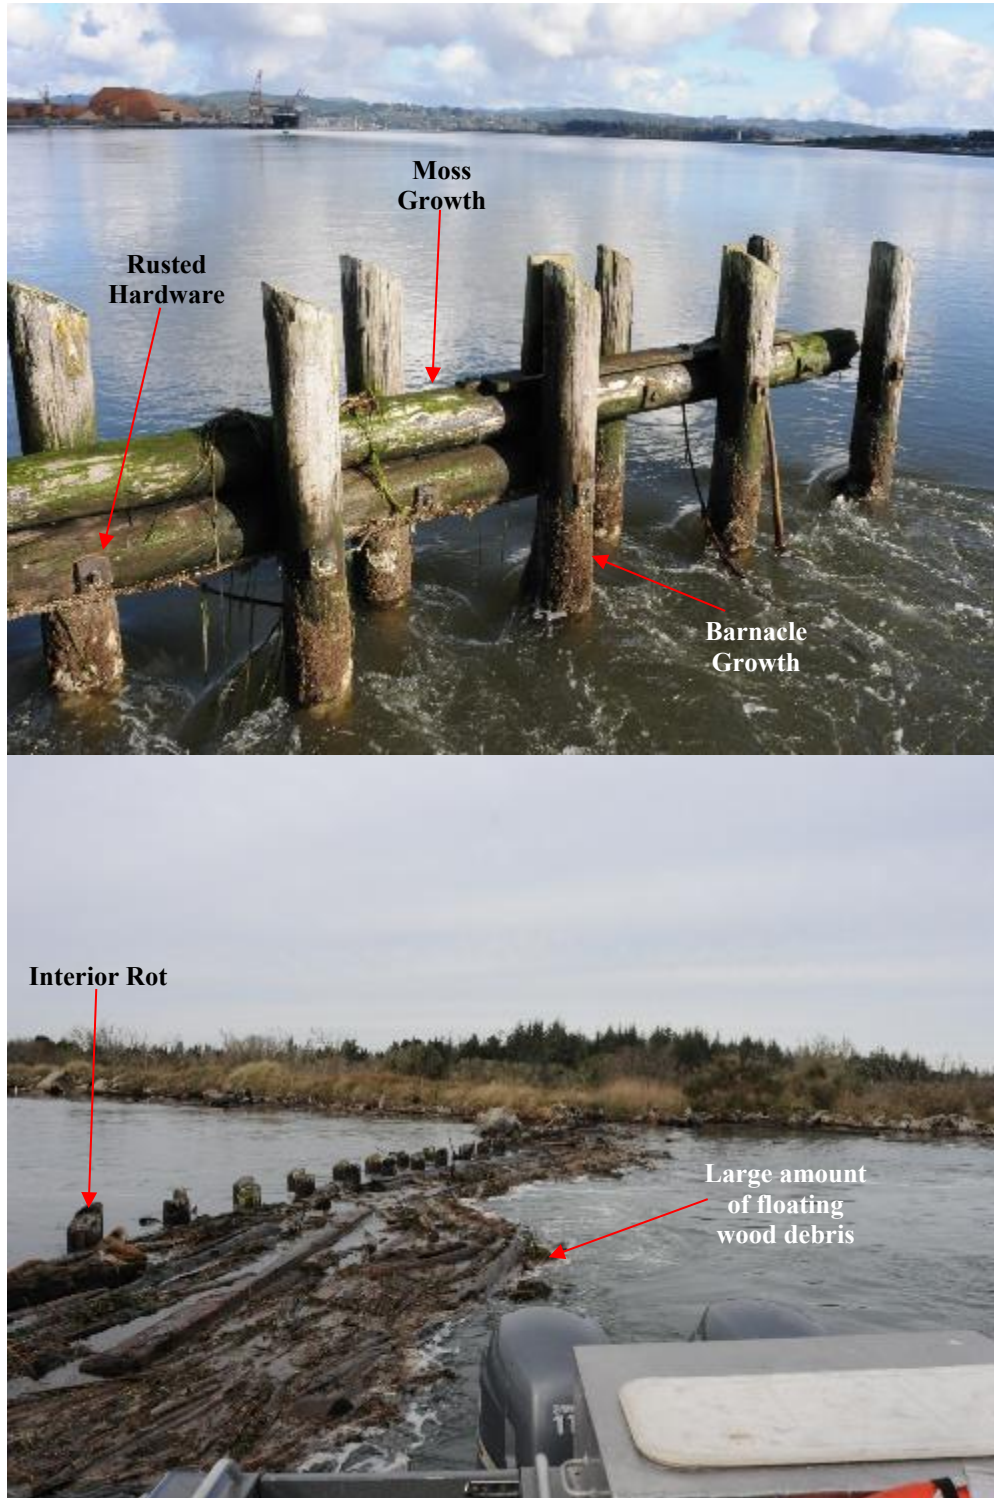
Figure 36. Pile Dike 7.3 photographs depicting the physical condition of the piles, hardware and floating debris during an ebb tide.

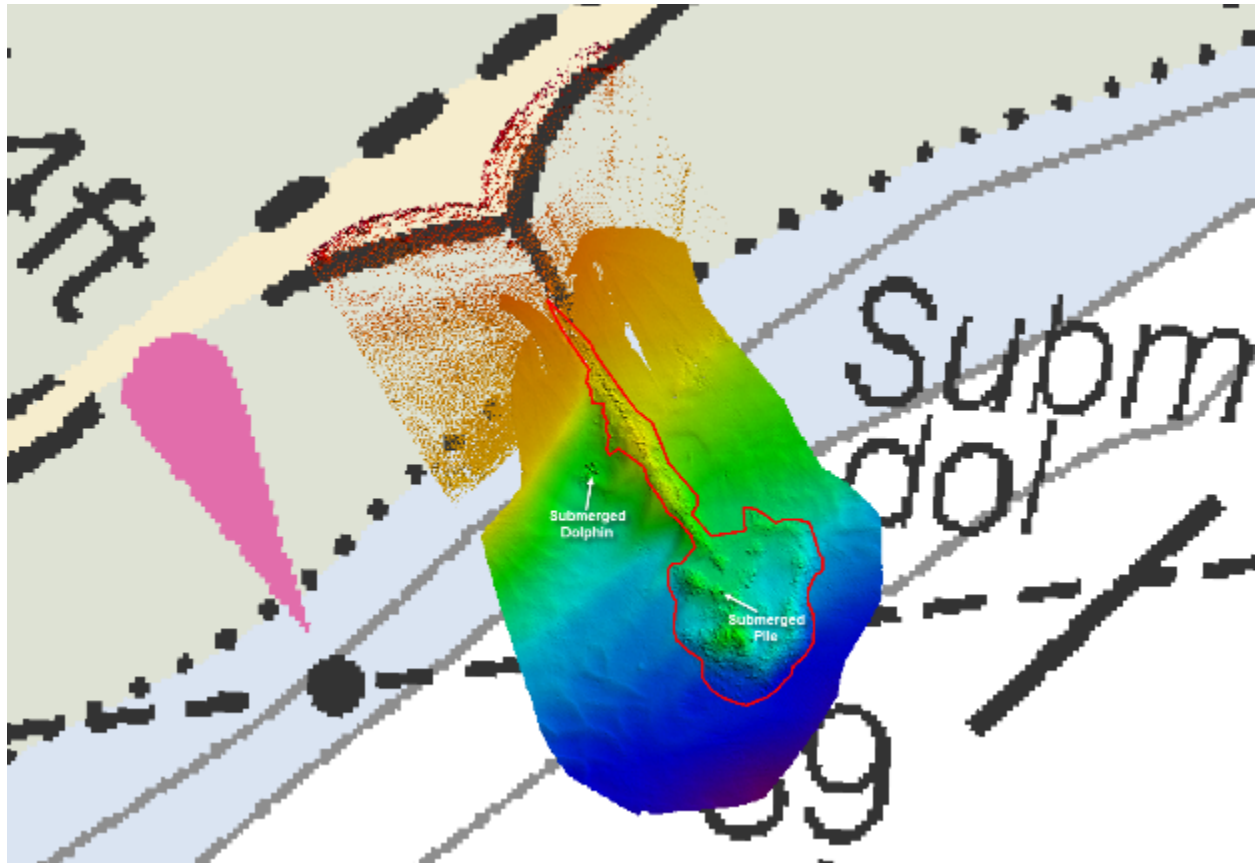
Figure 37. Pile Dike 7.3 plan view bathymetric hillshade depicting the extent of exposed armor rock (outlined in red) and the location of the submerged dolphin and submerged pile.
