OREGON INTERNATIONAL PORT OF COOS BAY WRDA SECTION 204(F) PROPOSED CHANNEL MODIFICATION COOS COUNTY, OREGON

BASELINE EELGRASS SURVEY – SEPTEMBER 2023

Submitted by:
Merkel & Associates, Inc.
5434 Ruffin Road
San Diego, CA 92123
(858) 560-5465

November 2023

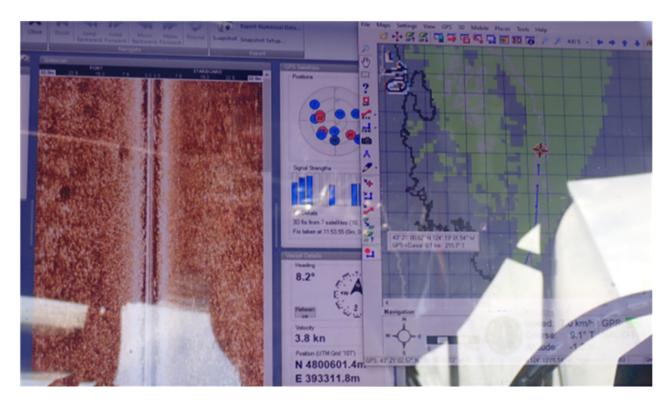
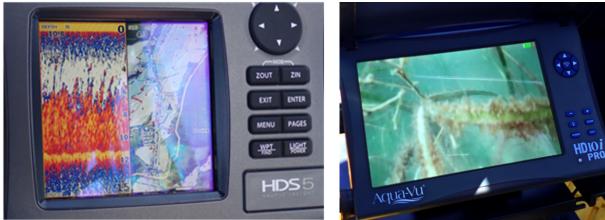
Sidescan sonar and navigation software (top) was used to track survey coverage over a survey chart with bathymetry and preliminary expected eelgrass derived from prior surveys. A single beam fathometer (bottom left) provided information for monitoring water depth and submerged hazards, while ground truthing eelgrass distribution during data collection. A towed video camera (bottom right) was deployed to spot-check sonar data.

Eelgrass spatial extent data was collected using high frequency sidescan sonar, which provided an acoustic backscatter image of the seafloor within the project area. Interpretation of the backscatter data allowed for an assessment of the distribution of eelgrass. Sidescan backscatter data was acquired at a frequency of 450 kHz scanning out 31 meters on both the starboard and port channels for a 62-m wide swath. A rigid vessel mounted system with integrated motion sensors to control for heave, pitch, and roll; a sound velocity sensor for speed of sound correction; and a dual antenna global positioning system (GPS) and electronic compass were used to control for vessel position and yaw. This rigid integration of the sonar transducers with the positioning sensors provides significantly increased precision and accuracy over conventional towed sidescan sonar equipment.

The survey was conducted by running parallel transects that are spaced to allow for overlap between adjoining sidescan swaths. Survey swaths were navigated until the entirety of the survey area supporting eelgrass was captured in the survey report. All data were collected in latitude and longitude using the North American Datum of 1983 (NAD 83), converted to the Universal Transverse Mercator system in meters (UTM), and plotted on a geo-rectified aerial image of the survey area.

Sonar surveys were also supported by use of a single-beam sonar operating at 200 kHz which provided information on presence or absence of eelgrass. Additional ground-truthing was completed by use of a towed video camera array that provided real-time visual observations that could then be annotated onto navigation data to support sonar analyses.

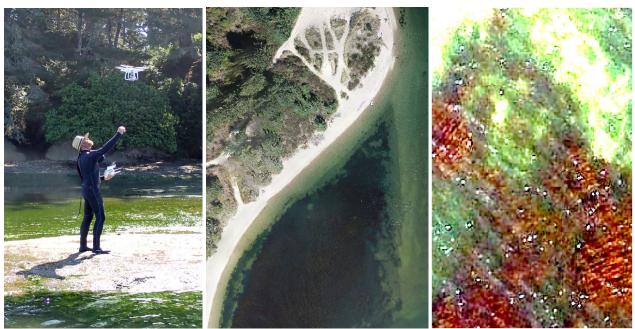
Aerial imagery was collected using a quadcopter UAV (left) with individual photos processed into an orthomosaic image (center). Following the mosaicking and registration process, spectral stretch algorithms were applied to illuminate eelgrass from macroalgae relying principally on red algal epiphytes on eelgrass that do not similarly colonize green algae.

Low-altitude true color aerial imagery of the Project Area was collected within lower Coos Bay including most of Hungryman Cove, Fossil Point, and Barview within the Coos Bay Range, as well as areas along the mouth of South Slough adjacent to Charleston Harbor on September 12 and 13, 2023. Flights further north within the project area could not be conducted due to airspace restrictions from the Southwest Oregon Regional Airport in North Bend. A DJI Phantom 4 Pro un-manned aerial vehicle (UAV) with a 20 mega-pixel (MP) camera was the imaging platform for the work. Automated flight control software was used to ensure the imagery was captured in a consistent manner with respect to flight altitude (300 ft) above ground level (AGL), front lap (75%) and sidelap (75%). Incorporating a higher image overlap ratio facilitates improved image alignment, and an enhanced ability to resolve partially or wholly submerged features that may be obscured by sun-glint, glare, or reflections off the water surface; these factors tend to reduce the useable extent of each image. Having the ability to mask out problem areas without sacrificing necessary overlap between adjacent images produces higher quality orthomosaics, based on the camera specifications of the Phantom 4 Pro and an altitude of 300 ft of approximately 3.0 cm/pixel (1.2 inches/pixel).

Aerial imagery was processed, color-corrected for exposure variation, mosaicked and orthorectified into a series of orthomosaics covering the Project Area using Structure from Motion (SfM) photogrammetry software (Agisoft Photoscan Professional). While the initial georeferencing of aerial imagery was driven by the onboard GPS associated with the Phantom UAVs which embed positional tags within each image's metadata, final post-processing georeferencing was completed by registration to fixed position features within the mosaic (e.g., navigational aids). Registered orthomosaic images were used to support digitization of eelgrass in waters shallow enough to accurately map bed boundaries. In deeper water boundaries were derived from the sonar mapping.

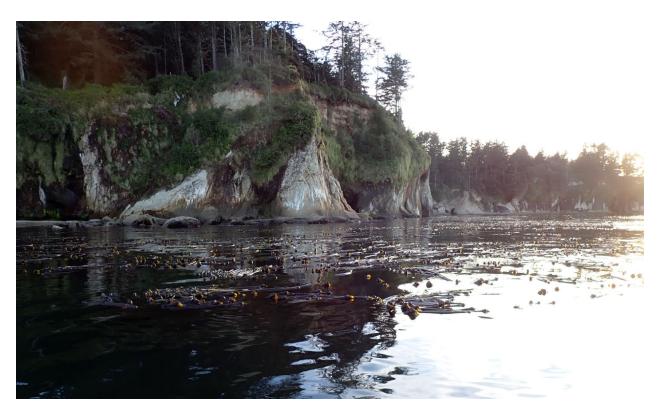
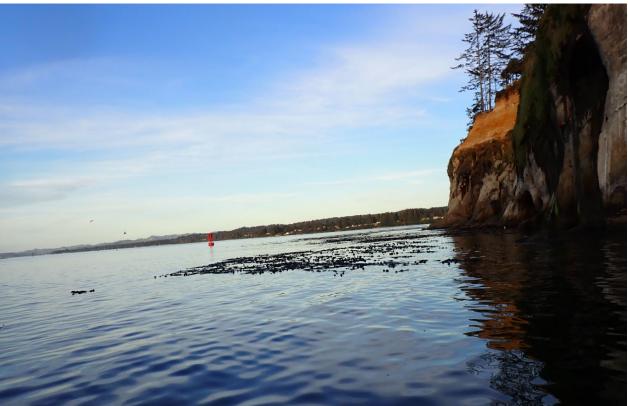
Bull kelp bed located at Coos Head within Coos Bay – September 2023.

Canopy kelp within Coos Bay is limited to bull kelp (*Nereocystis luetkeana*). A total of 3.51 acres of canopy kelp was noted within the bay. This was predominantly associated with the bedrock bottom at Coos Head within the entrance channel (Figure 3a). Most of the canopy kelp was found in small, tightly aggregated beds adjacent to the shoreline. Additional notable stands of bull kelp were observed on the submerged jetty extending outward from Log Spiral Bay. Small canopy kelp patches were also found on a segment of submerged pipe off the beach at Alaska Packer Road. Other bull kelp was limited to individual or a few stipes near the Fossil Point shoreline.

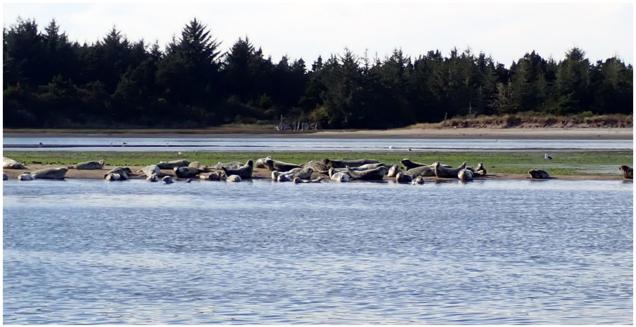
Harbor seals hauled out on an intertidal bar north of Clam Island – September 2023.

A notable observation was the presence of a moderate size seal haul-out on the upper end of Clam Island (Figure 5). This haul-out held between 10 and approximately 70 seals during multiple survey passes made along this area over the course of a week. The haul out area is intertidal and thus was only used during mid to low tides, although during higher tides, seals were observed further up on the beach on the margins of the supratidal Clam Island.
