**US Army Corps
of Engineers®**
Portland District

Oregon International Port of Coos Bay

Proposed Section 204(f)/408 Channel Modification Project

Channel Side Slope Analysis

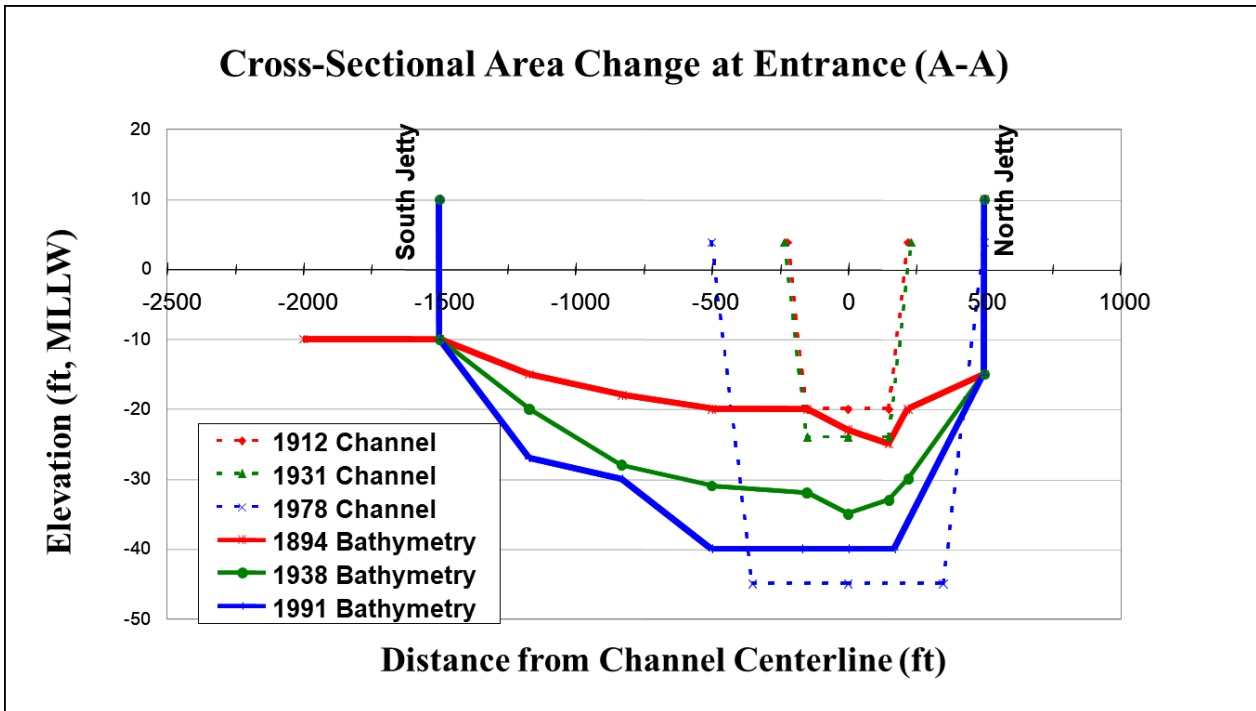
Figure 3-2
Steepening Side Slopes as the Coos Bay Entrance Channel is Deepened (USACE 2019)

Slopes flatter than the median measured side slopes are not expected to occur after channel modification. The effect of widening and deepening the channel has the effect of reducing current velocities throughout the channel, as shown by the detailed modeling presented in Sub-Appendices 3 and 4 (*Estuarine Dynamics* and *Offshore and Entrance Dynamics*). As a result, there is less hydrodynamic forcing on the tops of the slopes, and less potential for erosion of the slopes into the channel (“sloughing”). Work published by Fredsoe (1978) and Raaijmakers (2005) also indicates that deeper channel dredge cuts produce steeper equilibrium sides slopes. This relationship between channel depth and equilibrium side slopes can be seen in historical cross-sections charted at the Coos Bay Entrance (Figure 3-2). As the authorized channel depth increases in Figure 3-2, the slopes adjacent to the channel steepen.

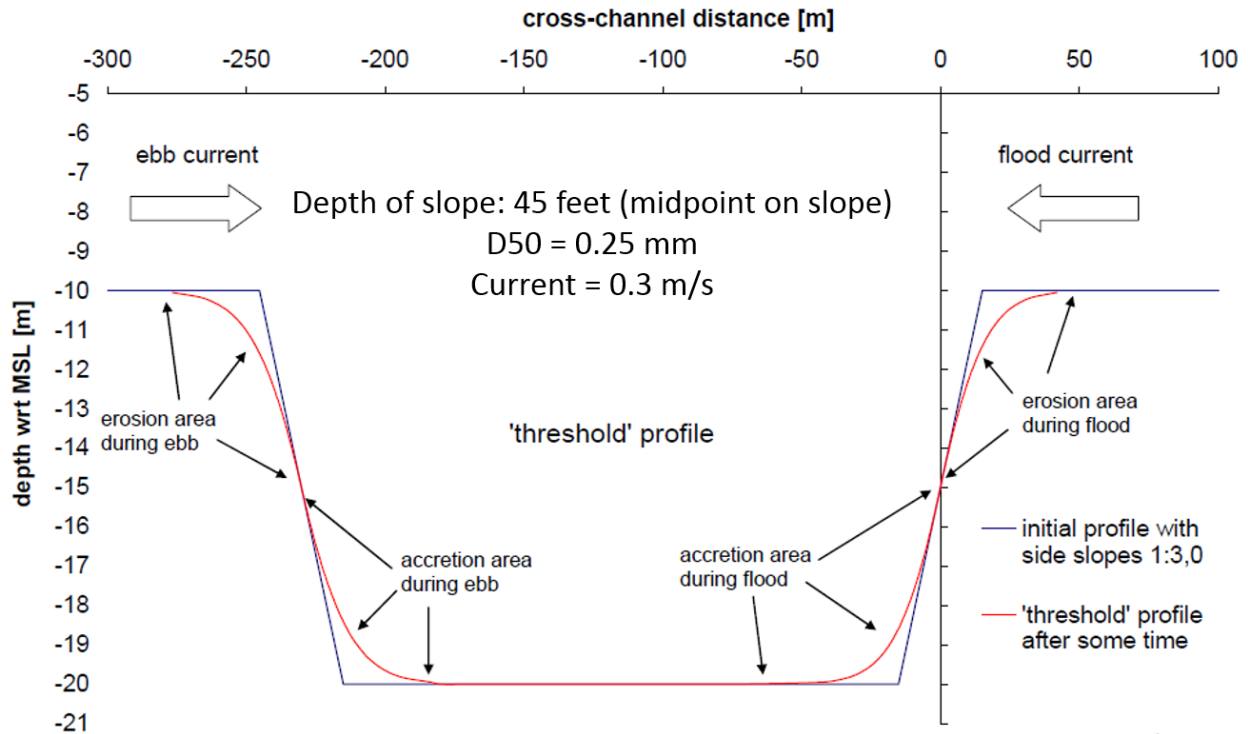
Figure 3-4
Schematic of the "Threshold Profile" (Source: Raaijmakers 2005)

The particular side slope angle to which the channel will equilibrate can be estimated by a set of equations provided by Raaijmakers (2005). This method predicts the development of a “threshold profile,” which is based on the assumption that bed load is constant throughout the cross section. For this assumption, the hydrodynamics are assumed to be such that sediment particles on the equilibrium side slopes are just stable (or at the threshold of motion, based on a shear stress analysis). This threshold profile is calculated by modifying the static stability and threshold of motion equations by stability reduction factors based on the geometry of the bed and the sediment properties. The equations themselves consider the depth, the slope height, the grain size, and the critical current discharge. A schematic of the initial and threshold profiles is provided in Figure 3-4.

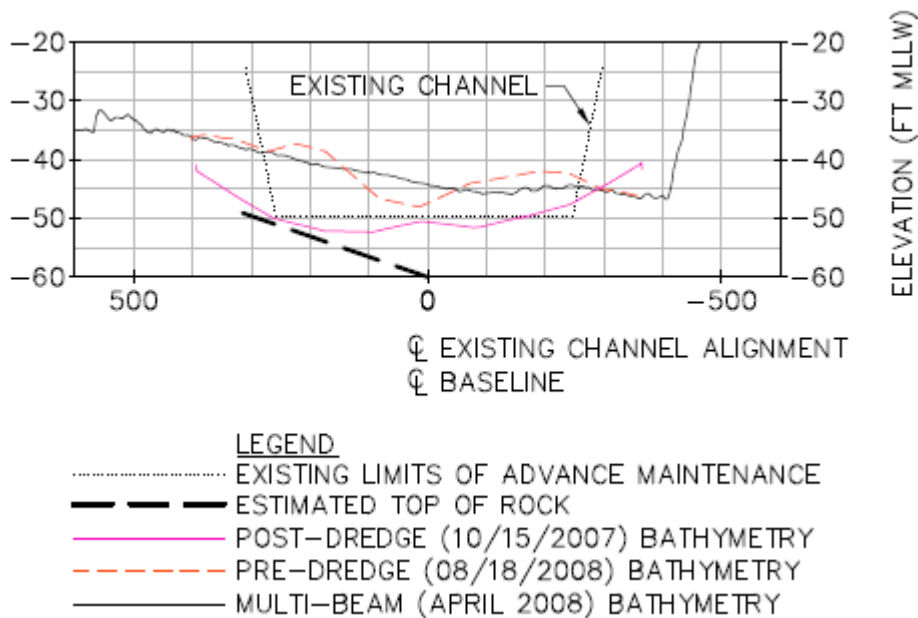
Figure 3-6
Shoaling at Station 22+50 from October 2007 to August 2008

Figure 3-6 and Figure 3-7 show the shoaling at Station 22+50 that occurred from 2007 to 2008 and from 2008 to 2009, respectively, by comparing pre-and post-dredge surveys provided by USACE. (It should be noted that all cross sections presented in this report are oriented to face downstream.) While these surveys do not offer full coverage of the channel and have coarse spatial resolution, they clearly show the magnitude of sediment infill that occurs annually. Shoaling occurs over the entire cross-section; material is not lost from the top of the cross section into the channel but accretes throughout. After channel modification, this observed pattern of shoaling across the entire cross-section is expected to continue; in fact, shoaling is expected to increase (Sub-appendices 3 and 4) both within the channel and along the side slopes as a result of increased channel trapping efficiency or mobilization of additional sediment. Therefore, the net behavior is material accumulating on the tops of the slopes, not sloughing into the channel bottom. A more detailed discussion of future shoaling in Reach 3 is presented in Section 4.2.4.3.

- **Shoaling.** The long-term process of side slope evolution is expected to take 8 years (see Section 3.2.4.3). In certain reaches, however, shoaling occurs annually over the entire cross section – from the toe of slope through the top of slope (Figure 3-6 and Figure 3-7). As noted above, equilibrium side slopes are defined as the slope angles that are expected in the channel after the effects of capital dredging no longer affect channel morphology. In areas of the channel where the timescale of shoaling is less than 1 year, maintenance dredging records show that shoaling occurs annually and the morphology is dominated by this annual pattern of shoaling and dredging, not by a response to deepening.

The channel line surveys are limited by their coarse resolution, but do provide temporal variability. They are particularly useful for estimating shoaling from one year to the next (see Figure 3-6 and Figure 3-7). These surveys were also selected for the measurement of side slopes in Reach 1, due to the lack of other data. The annual surveys in Reach 1 vary widely. Therefore, the side slope is computed for each year.

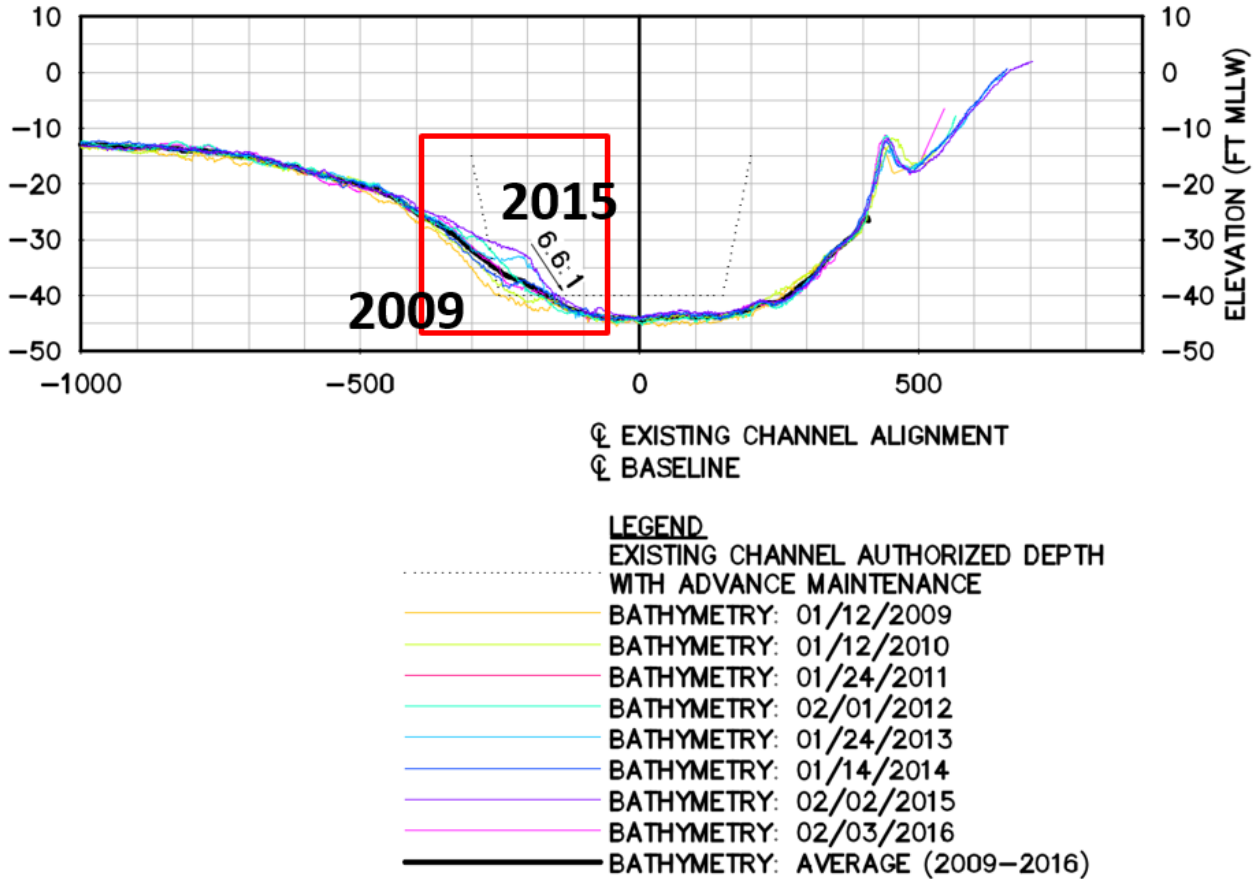
Figure 3-8
Deposition on the Inner Slope of Station 375+44 (Approx. RM 7.1)

The same occurrence can be observed in the Reaches 8 and 9, along the inner bank of Jarvis Turn. Examining the cross section at Station 375+44 (Figure 3-8) it can be seen that on the inner bank (left side) sediment has been steadily accumulating from 2009 through 2015 (see the area in the red box). Despite the apparent shoal at the bottom of the channel, no loss of sediment is occurring on the upper portion of the side slope. This may indicate that the sediment accumulation at the bottom of the channel may be sourced from elsewhere in the channel. It could be from another part of the bay, or even from erosion on the outer bend of Jarvis Turn. After channel modification, this area is still expected to be depositional, with material depositing on the bottom of the channel, appearing to flatten the slope.

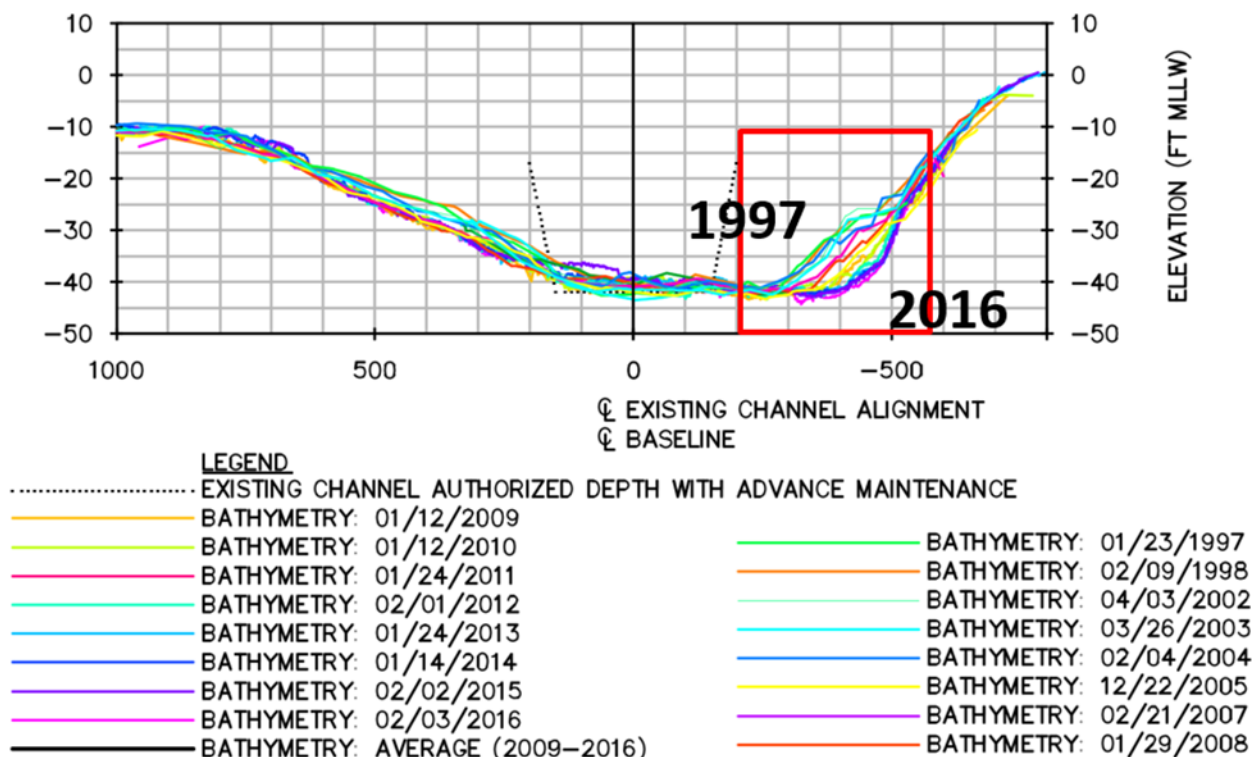
Figure 3-9
Erosion of the Outer Slope at Station 345+54 (Approx. RM 6.6)

This process is particularly evident at Station 345+54 (Figure 3-9), where the slope evolved from 10:1 to 3:1 over 10 years because of erosion. After channel modification, erosion is expected to continue; therefore, it is reasonable to expect that the side slopes may become even steeper after dredging. The median side slopes are used as the basis for future equilibrium side slopes for purposes of estimating capital dredge volumes as well as O&M dredge volumes and analysis of project effects.

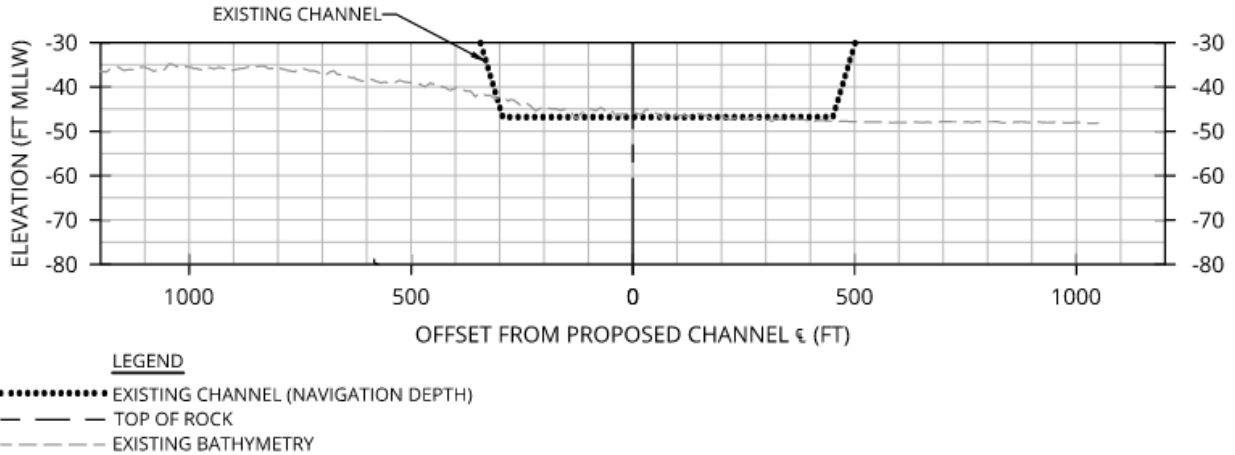
Figure 4-3
Reach 1 Representative Cross Section, Existing Condition (Station -5+10)

The one resource present in this Reach is ODMDS E. However, dredging into ODMDS E is not anticipated to mobilize a significant volume of sediment, as there is no mound of sediment there. Cross sections at Stations -0+57+16 and -0+52+80 in Sub-appendix 13 (*Cross Sections*) show the bathymetry south of the channel, where ODMDS E is located to be flat. A complete description of the effects of dredging in the vicinity of ODMDS E is presented in Sub-appendix 10 (*Dredged Material Disposal Sites*). A representative cross section, measured at Station -5+10, can be seen in Figure 4-3. This cross section is shown at a 10x vertical exaggeration.

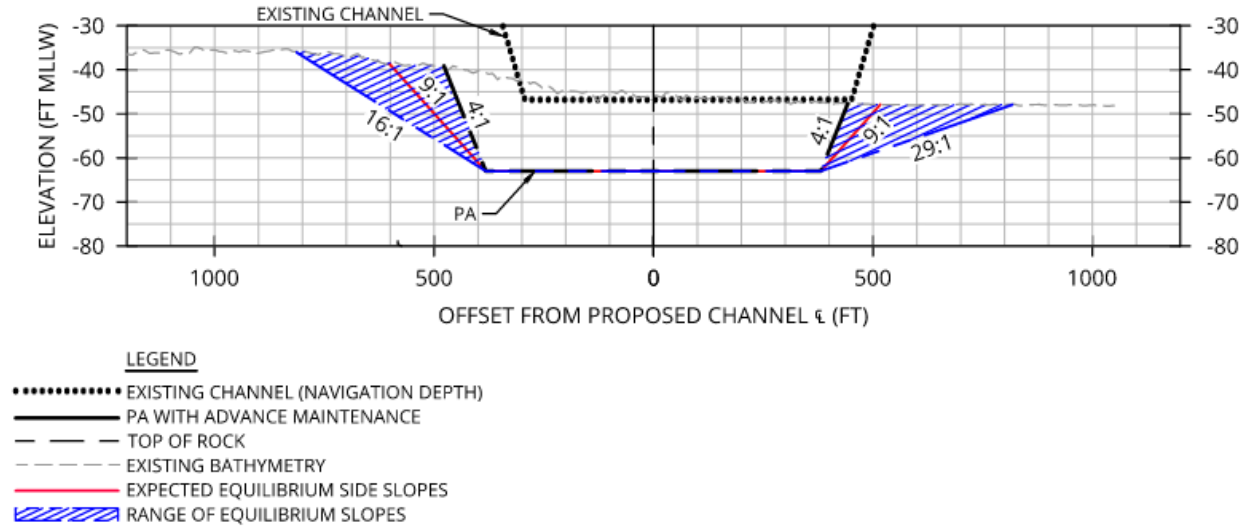
Figure 4-4
Reach 1 Representative Cross Section, PA Condition (Station -5+10)

A representative cross section of the equilibrium side slopes under the PA shown at a 10x vertical exaggeration can be seen in Figure 4-4; true scale representations of the left and right slopes are depicted in Figure 4-5 and Figure 4-6, respectively. Cross sections in this reach at both exaggerated and true scale for the construction and median side slope angles can be seen in Stations -0+57+16 through 0+5+00 in Sub-Appendix 13 (*Cross Sections*).

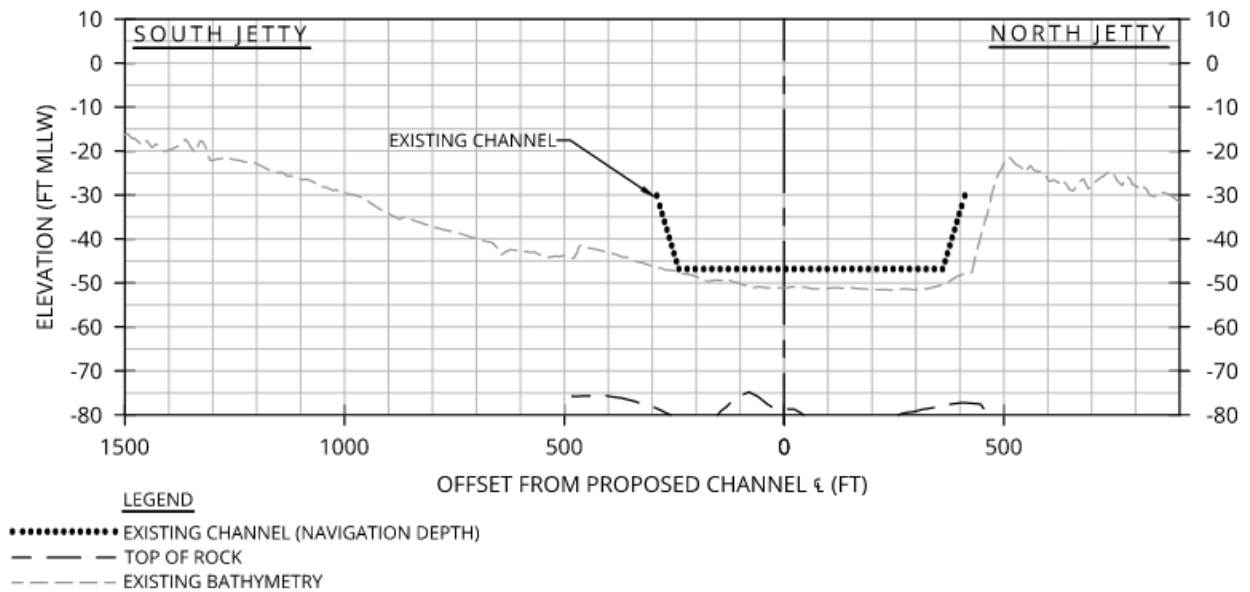
Figure 4-9
Reach 2 Representative Cross Section, Existing Condition (Station 12+49)

The representative cross section illustrated in Figure 4-9 shows the steep jetty slopes, and the milder slopes in sediment adjacent to the structures; this cross section is shown with a 10x vertical exaggeration. To the left of the channel, sediment slopes from the South Jetty at -20 ft MLLW to the channel at a slope of 22:1. On the right side of the channel, the sediment slopes from the North Jetty at -45 ft MLLW to the channel at a slope of 15:1.

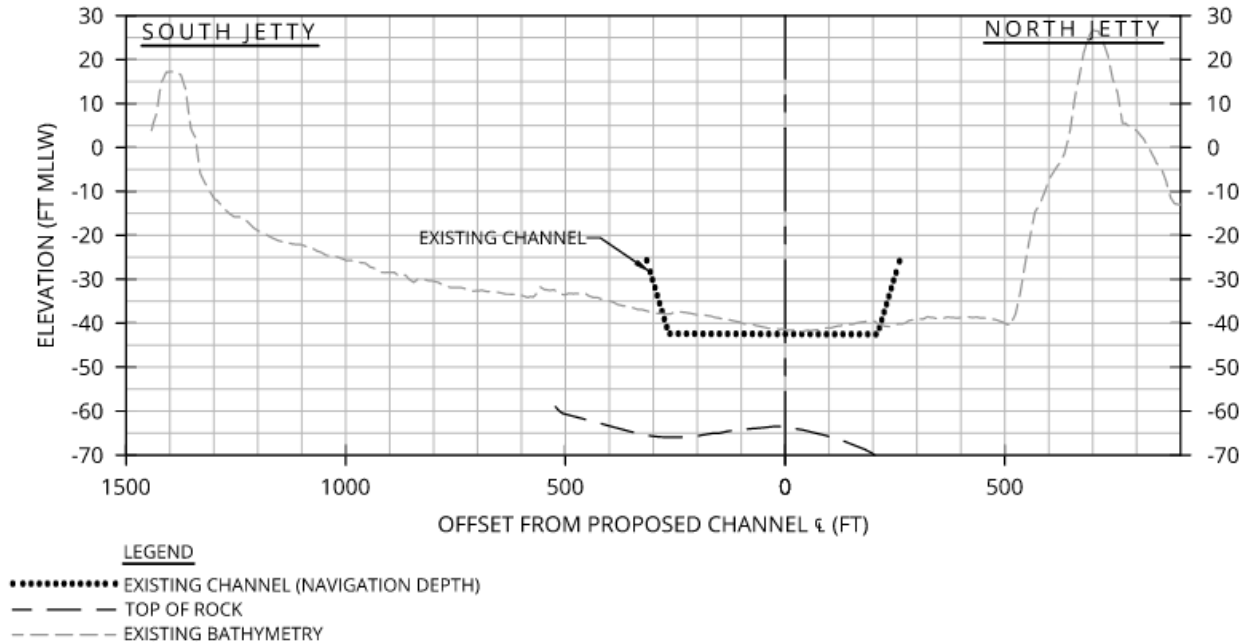
Figure 4-15
Reach 3 Representative Cross Section, Existing Condition (Station 27+75)

The representative cross section illustrated in Figure 4-15 shows the tall, steep jetties, and the milder slopes in sediment adjacent to the structures; this cross section is shown at a 10x vertical exaggeration. To the left of the channel, sediment slopes from the South Jetty at -20 ft MLLW to the channel at a slope of 22:1. On the right side of the channel, the sediment slopes from the North Jetty at -45 ft MLLW to the channel at a slope of 15:1. In Figure 4-15 infill is present within the channel and therefore the 15:1 side slope on the right side of the channel is not apparent.

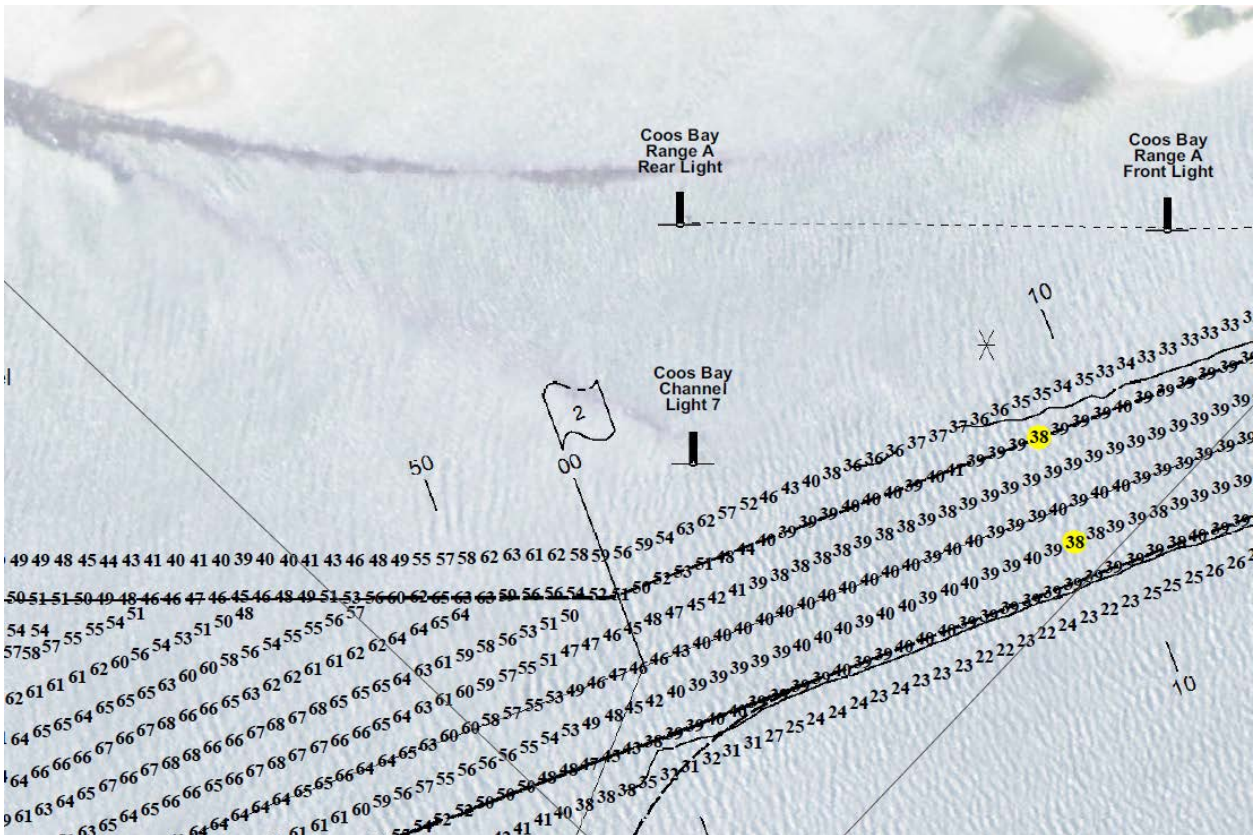
Figure 4-25
USACE Survey Data in the Vicinity of the Rail Spur (Coos Bay Channel Light 7)

One particular morphologic feature of interest in this reach is the scour hole adjacent to the rail spur. Figure 4-25 shows channel line survey data in the vicinity of the rail spur; the tip of the structure is marked with “Coos Bay Channel Light 7.” In the vicinity of this feature, the channel bed has a depth of 52-63 ft below MLLW. In this area, dredging will not be required as the present bathymetry is sufficiently deep. Because dredging will not be necessary, side slope equilibration is not expected.

The rail spur is the portion of the North Jetty that extends from the main structure towards the channel; it is located at approximately RM 1.9 through 2.1. It is closest to the channel at RM 2.1, where it is approximately 200 ft away from the channel. Over time, the presence of this structure has resulted in significant scour, with a permanent scour hole surrounding the structure. This scour hole ranges from 52 to 63 ft deep (Figure 4-25), or deeper than the proposed dredge cut. Therefore, side slope equilibration is not expected to affect this portion of the North Jetty. Detailed cross sections at the rail spur are shown in Sub-Appendix 13 (*Cross Sections*).

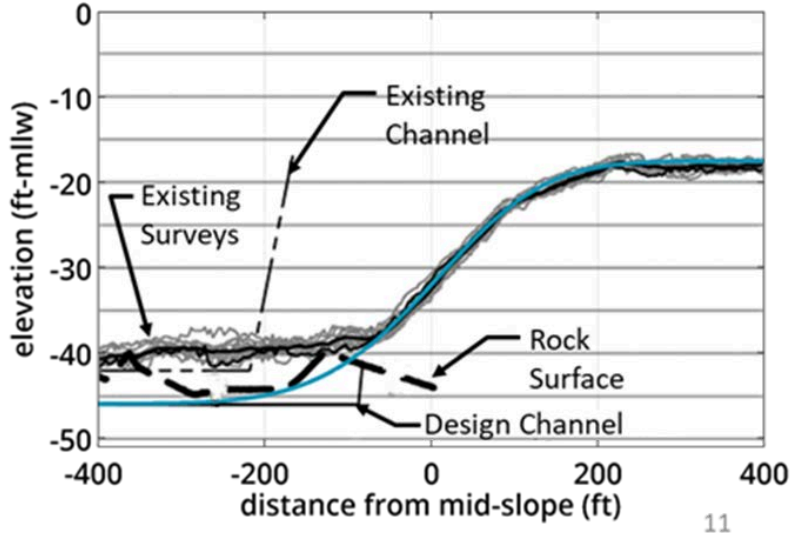
Figure 4-36

When taking into consideration site and geotechnical variability, the modeled side slopes varied from 8:1 to 12.5:1. Given the conservative nature of the calibrated model, the future equilibrium side slope used to calculate the capital dredge volume for Reach 6 is estimated at 9:1 (Figure 4-36).

Estimated Side Slopes for the PA at Station 265+54 (output after 8 years shown)

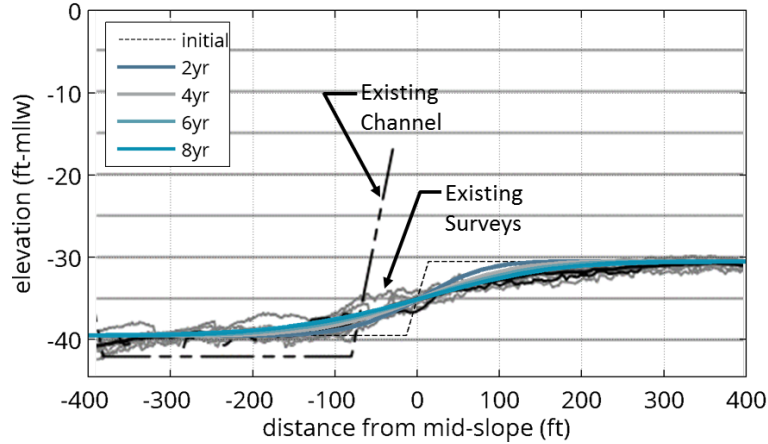
Figure 4-43
Calibration to Existing Conditions at Station 321+51

The calibrated model performs well. Using sediment properties from a boring located within this reach, the model reproduces side slopes within this reach. Calibration results for Reach 7, along with measured side slopes, can be seen in Figure 4-43. For model calibration, an equilibration timescale of 8 years was considered, and results are displayed at two-year intervals. This is consistent with the timescale of equilibration stated in Section 3.2.4.2.

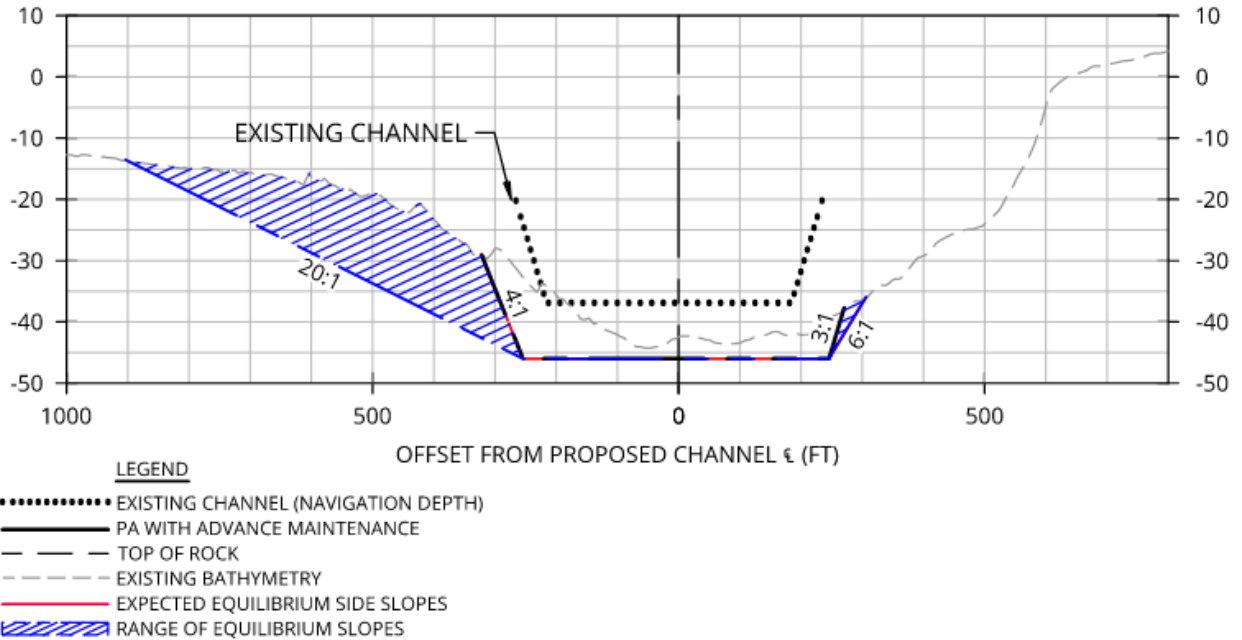
The future equilibrium side slopes based on long-term morphologic considerations in this reach can be seen in the representative cross section, depicted in Figure 4-54; this cross section is shown with a 10x vertical exaggeration. True scale representations of the left and right slopes are depicted in Figure 4-55 and Figure 4-56, respectively. The left and right equilibrium side slopes for this reach can be seen in exaggerated true scale in sections 6+21+12 through 7+10+56 (17 sections total) in Sub-Appendix 13 (*Cross Sections*). The airport would be on the far left of the sections 7+0+00 through 7+10+56, however it is so far from the daylight of the 20:1 slopes that it is not present in these figures.

Figure 4-54
Reach 8 Representative Cross Section, PA Condition (Station 375+48)

The airport is sufficiently far from the proposed channel modifications. Based on the future equilibrium side slope, equilibration is not expected to undercut the structure. As shown in Figure 4-54 and Figure 4-60, the side slopes are expected to daylight to the present bathymetry well away from the location of the airport. Therefore, effects to this structure are not anticipated. The airport would be present on the far left of section 7+0+00 through the end of Sub-Appendix 13 (*Cross Sections*). However, structure is a significant distance from the daylight point of the 20:1 slopes it is outside the cross section limits.

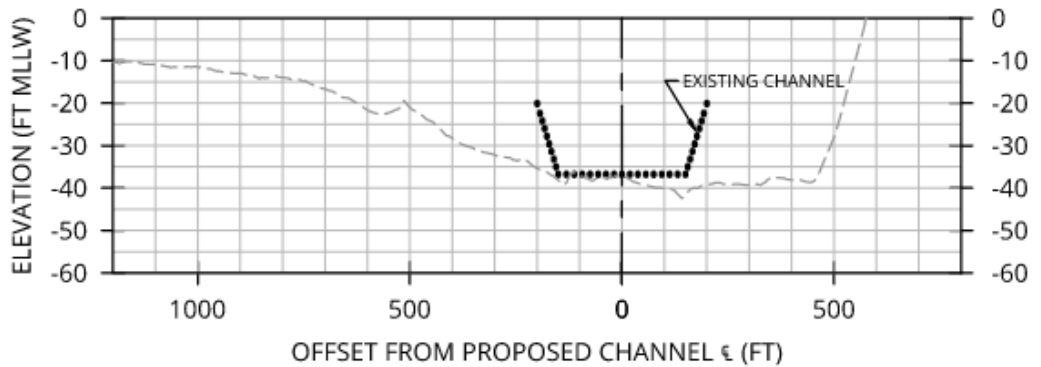
A representative cross section from this reach, taken at Station 408+07 (RM 7.7), is illustrated in Figure 4-59; this cross section is shown at a 10x vertical exaggeration. This cross section shows the left slope encroaching into the existing navigation channel; the channel’s tendency to migrate towards the right bank results in shoaling along the left slope.

Figure 4-59
Reach 9 Representative Cross Section, Existing Condition
(Station 408+07/RM 7.7)

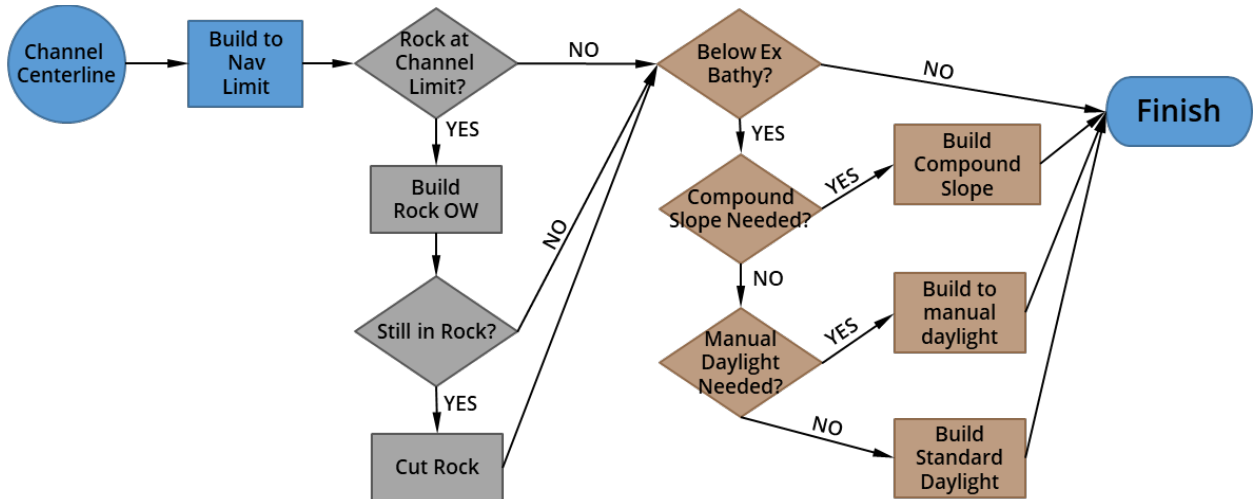
The channel with future equilibrium sides slopes was modeled using Autodesk Civil 3D and Autodesk Subassembly Composer. The model template was configured in the Subassembly Composer and written so that the template could adapt to a variety of conditions. Figure 5-1 shows a simplified version of the model template logic that was created within the Subassembly Composer. The channel template model was then loaded into Civil3D, the inputs were defined (i.e., substrate material, presence of a compound slope, or manual daylight point/structure – as explained below), and the full channel was built.

Figure 5-1
Simplified Civil 3D Subassembly Model
